## INVESTIGATION REPORT

2007 NEWMAR DUTCH STAR 4320

BUILDING FIRE WITH MOTORHOME

2018-129-C

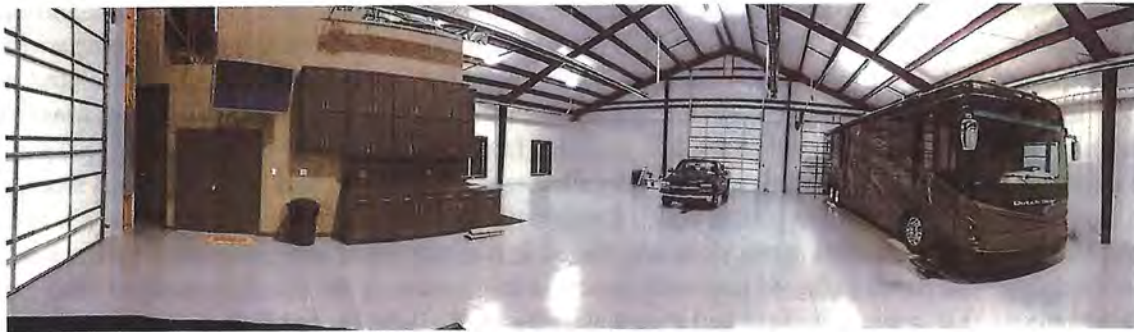
Hoog Client Photos - \_0010.jpg view from northwest corner

The electrical service entered the building from an outside panel at the northeast corner of the apartment. Fire damage/spread patterns and arc mapping indicated the fire originated in the area where the electrical service entrance was located and spread into the building via the path into the electrical distribution panel. This area was located adjacent to a storage area, which included a series of cabinets that were mounted to the exterior wall of the apartment and into the area between the apartment wall and the exterior wall of the building. The wall was finished with painted gypsum board with the cabinets attached and containing various items. The cabinets and the items inside would be fuel for the fire as it moved toward the south along the west wall of the apartment from the area of the north wall of the building and the north end of the apartment's west wall.

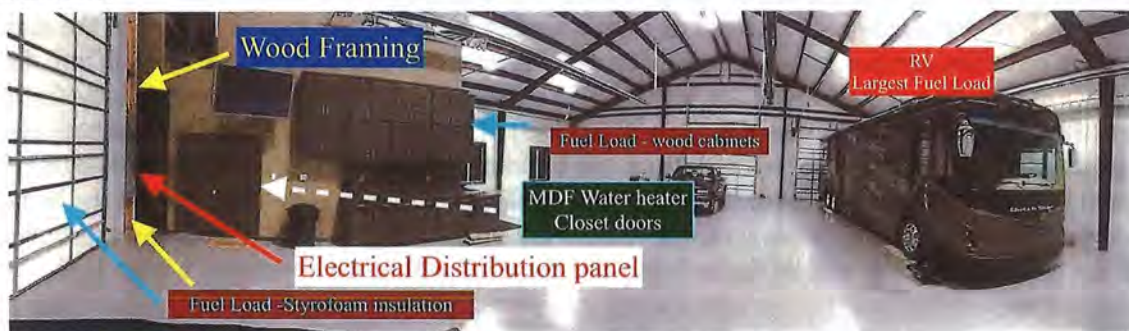
Hoog Client Photos IMG\_0010 annotated .jpeg

The RV was the largest fuel load in the building. Its proximity to the west wall was the cause of the damage to the interior of the west wall and to the structural components above. The extensive damage in this area does not indicate the area of fire origin but only the location of the greatest heat generated based on the amount of fuels present in the area. The RV was not the only fuel source in the area. Several propane bottles were located on rack storage along the west wall of the building. Areas of greater damage require extra attention and consideration. This consideration should include an estimate of the amount of BTU's generated in the area allowing a comparison of the expected damage to the actual damage. In this case the combination of the fuel related to the RV and the additional fuel packages along the west wall combined to create the area of greatest damage. The fuel package related to the RV includes but is not limited to the following: propane in the onboard storage tank (approximately 80-gallon tank), the diesel fuel in the onboard storage tank (approximately 250 to 300-gallon tank), furnishings and finishings in the coach, the six tires on the coach and various other items normally found in a recreational vehicle needed by the users while camping. The items gathered normally continue to increase as the coach is used, as each trip is an adventure that generates stuff and every activity sheds light on needing something else to make the adventure more comfortable. We were not provided a contents list for the coach. The fire spread to the coach after the Cadillac and the east garage door on the north wall became involved in the fire.

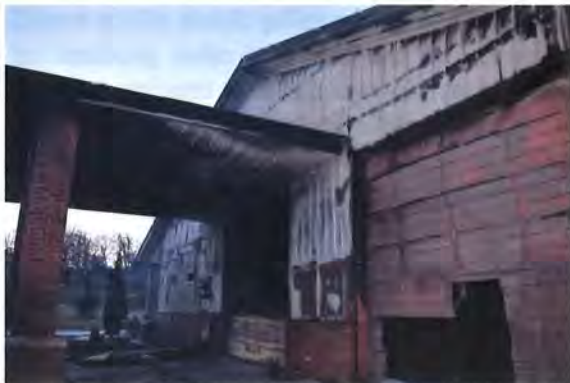
Edmund FD photo 44 North end Doors

- The roll up doors were metal on the exterior and contained what appeared to be Styrofoam insulating panels on interior side of the doors.
- The damage to the northwest and southwest roll-up doors is not consistent with the fire originating in the coach.

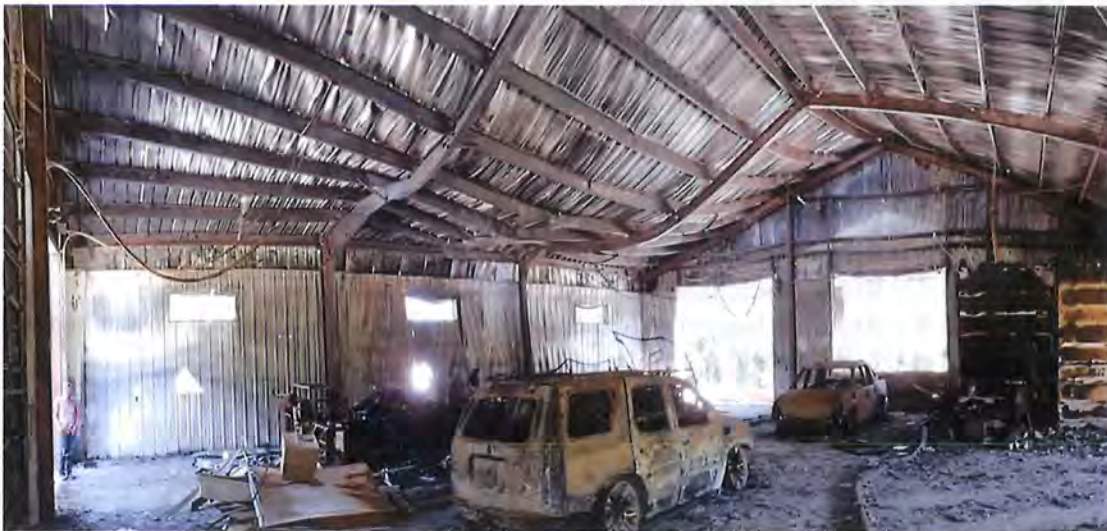
2018-129-C Photos 31-33 Stitched.jpeg

These windows provided ventilation once the fire compromised the dual pane windows. The windows were located just below the top of the panels that line the interior of the building. The level of the window allowed it to be the primary ventilation of the building after the fire breached the windows. Part of the south wall of the apartment is shown in the right side of the photo.

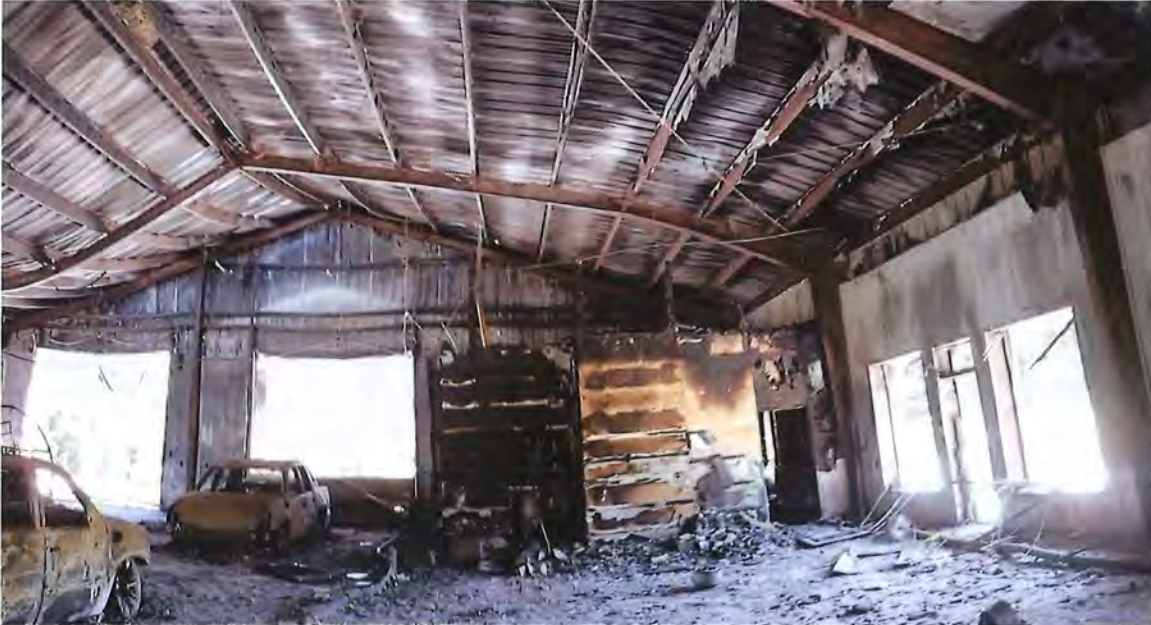
2018-129-C Photos 29-30 Stitched.jpeg

The photo above shows the northeast corner where the apartment is located on the north wall of the building, the east wall that includes the entry door and the location and proximity of the Cadillac EXT to the apartment, north door and the area of the electrical service entrance, and the Cadillac Excalade's position in relation to the EXT. The section of the south facing wall also contained a large amount of wall mounted wooden cabinets, but they did not face any of the larger fuel packages. Again these cabinets were installed over painted gypsum board.

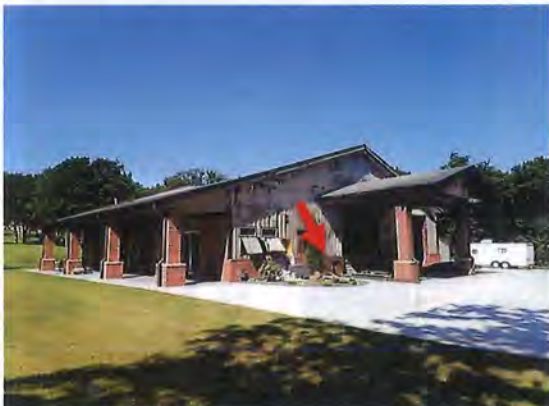
Photo 8 showing the northeast corner of the building

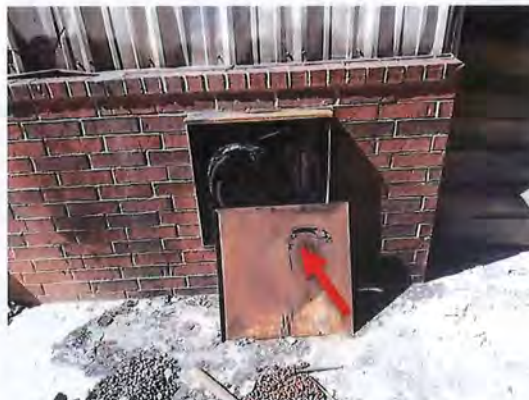
Photo 103 showing the arc gouge on the cover and the staining of the bricks

Electrical activity was found in the electrical service entrance. An arc gouge was observed on the cover for the metal enclosure. Evidence of damage to the wiring was obvious. The cause of the damage was due to an attacking fire from the burning wood located near the service entrance on the exterior of the building. The location of the arcing explained why there was no evidence of electrical power being present in the building because this arcing in the service entrance would have opened the pole top fuse or other circuit protection device that separates the utility distribution system.
